THE HERITAGE COUNCIL
OF WESTERN AUSTRALIA
HERITAGE ASSESSMENT
BOULDER SUBWAY
BOULDER STATION, BOULDER
GOLDEN MILE LOOPLINE RAILWAY

OCTOBER, 1993

G B HILL & PARTNERS PTY LTD
62 COLIN STREET
WEST PERTH WA 6005

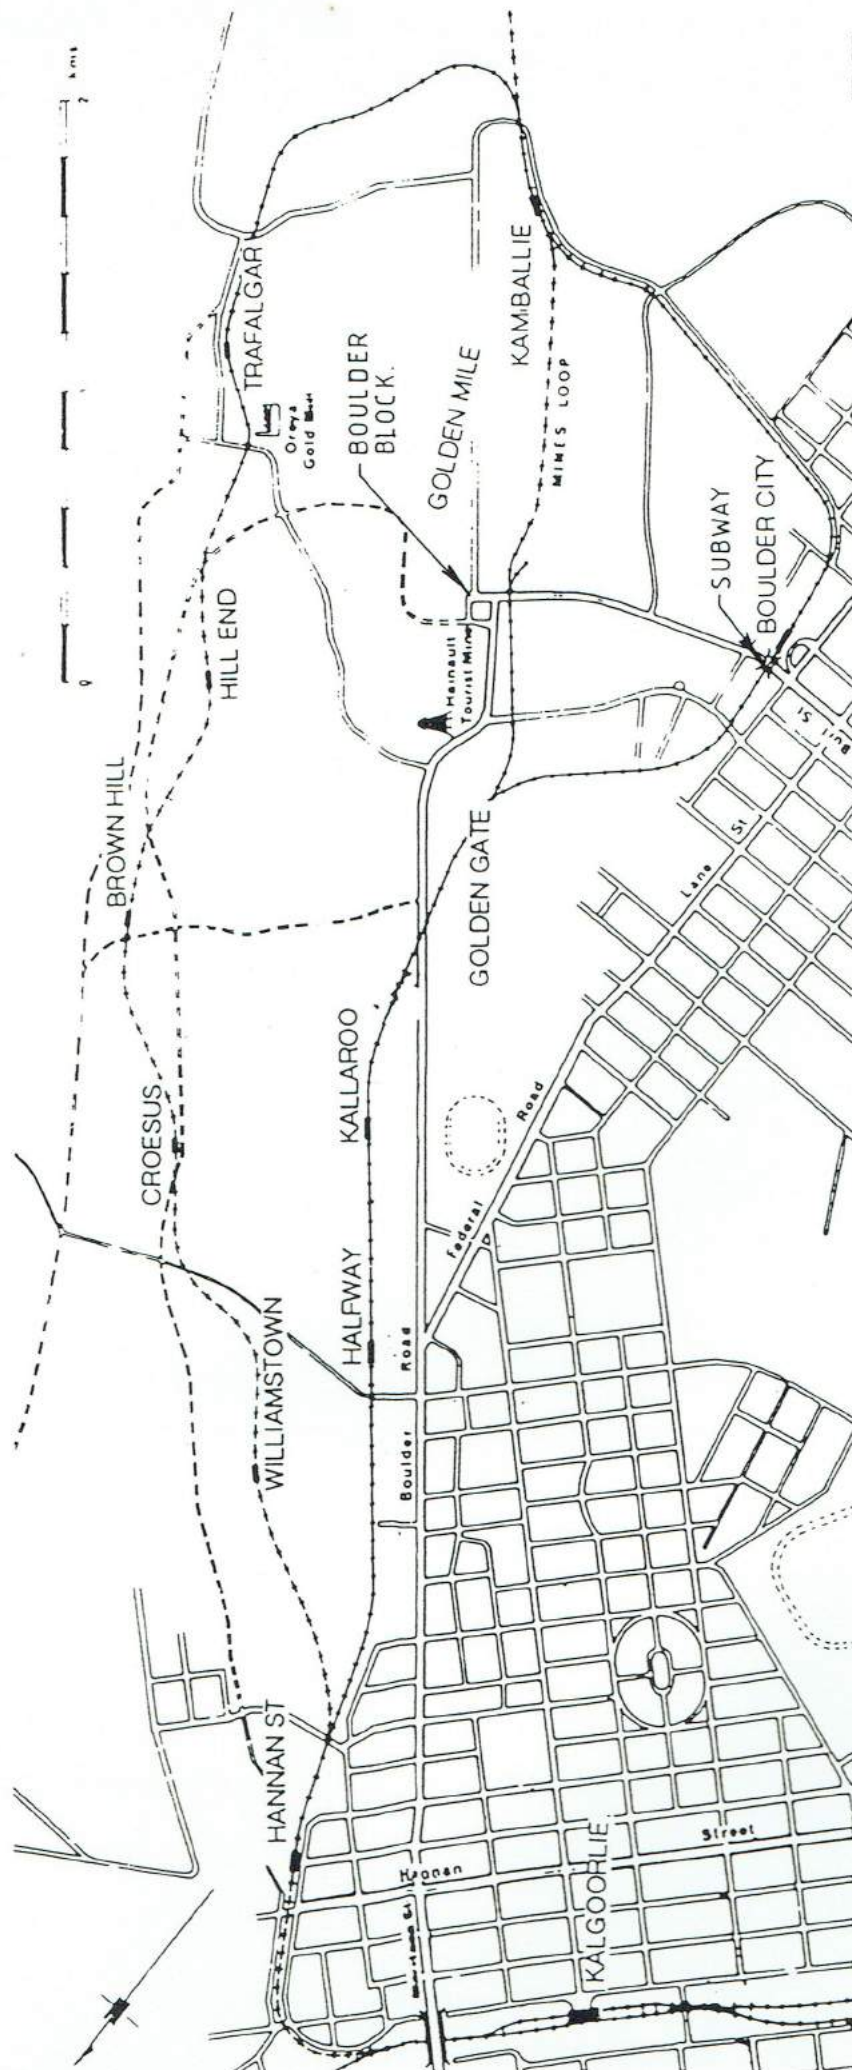
FIGURE 1:
BOULDER BRANCH
RAIL LAYOUT.

Following initial construction the railway was upgraded with additional tracks being added, and in March 1902 extension of the railway through Brown Hill and connecting back to the Hannan Street station was opened to form a complete 14 kilometre long rail loop encompassing the Golden Mile mines. The outline of the rail loop or the Boulder Branch as it was called and eleven stations is shown in Figure 1.

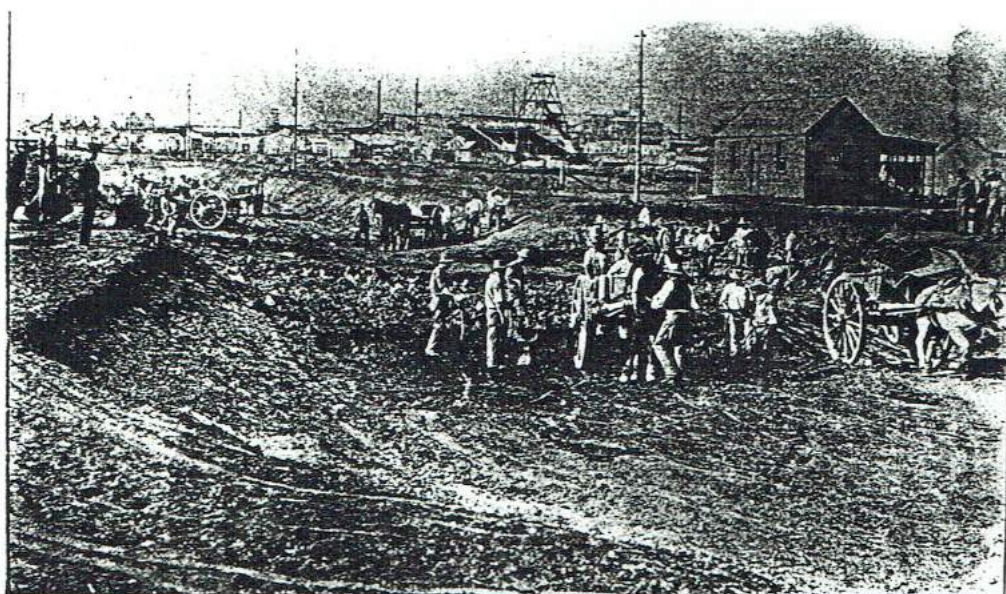
BOULDER SUBWAY UNDER CONSTRUCTION. FIGURE 3.

WORKING ON THE APPROACH TO THE SUBWAY, BOULDER RAILWAY STATION.
(H. C. Watson photo.)

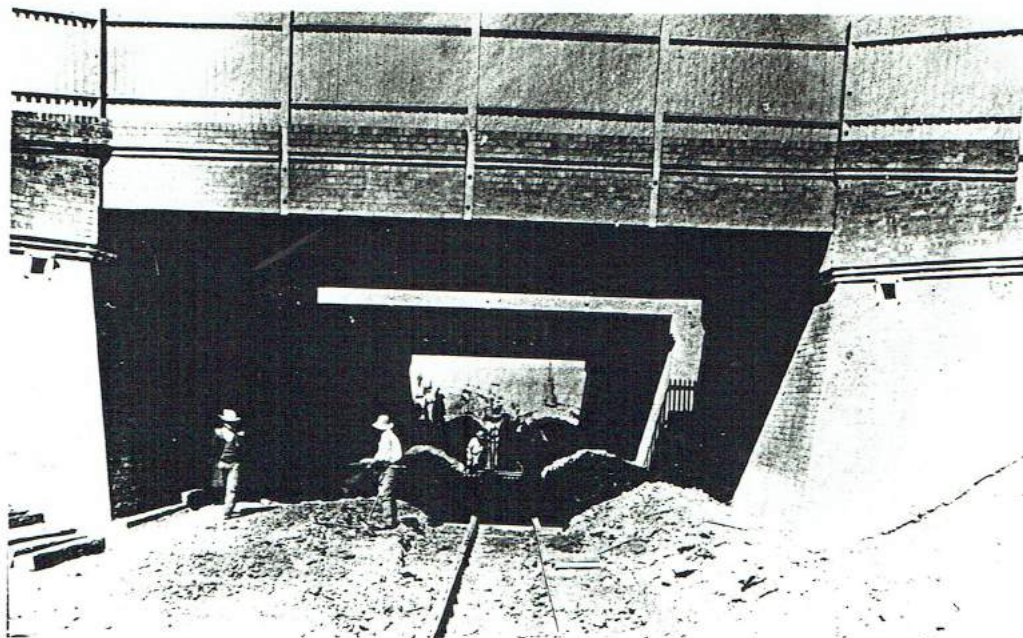
LAYING TRAM TRACKS UNDER BOULDER SUBWAY 1903. FIGURE 4.

Burt Street the central city street of Boulder connected under the subway leading to the mines, Fimiston and the Boulder block. Tram tracks were laid through the subway in 1903 (Figure 4).

Although the tramways provided an important passenger facility these have been removed and there is little remaining evidence. Figure 4 indicates the laying of the tram tracks through the subway in 1903.

The timber picket fence shown on the original plans (Figure 4 and Appendix 2) has been removed, although the bases of the timber posts remain.

The inclusion of architectural features in the original construction such as the brick parapet walls (Figure 4) illustrates the importance at the time to making the subway aesthetically pleasing.

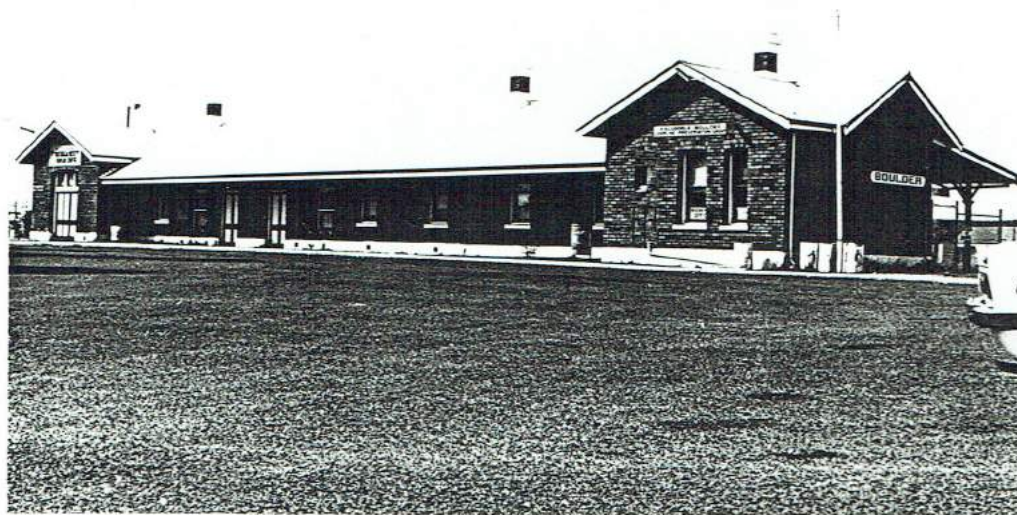
BOULDER RAILWAY STATION BUILDING. FIGURE 6.

The Boulder Station buildings are well maintained (Fig 6) and utilised to house a historical display and to service the tourist loop railway.

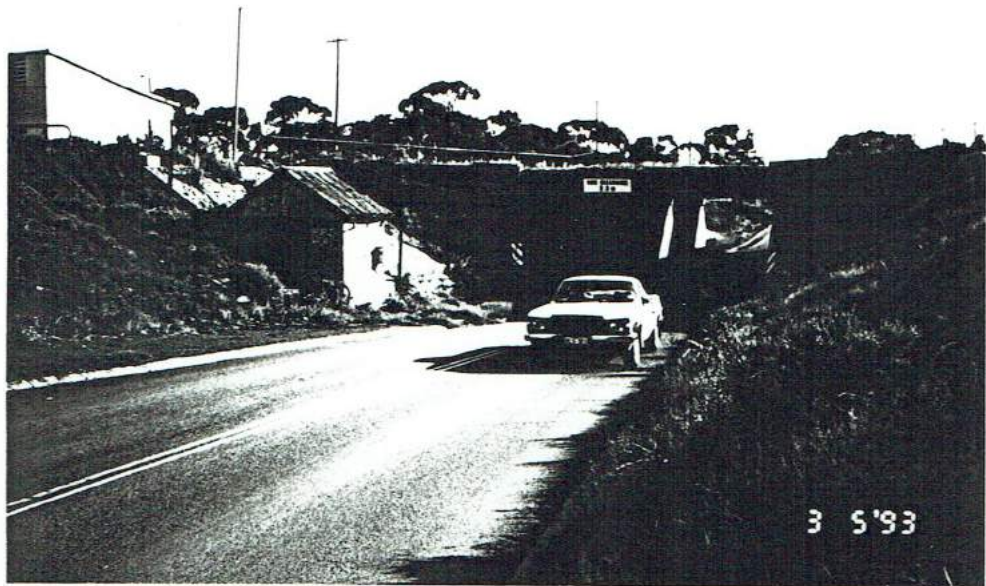
FIGURE 7.

The subway structure and bridge (Figure 7) represents the original construction including the Coolgardie brick retaining walls and riveted steel bridging which are in a reasonable serviceable condition.

PHOTO OF EXISTING SUBWAY.

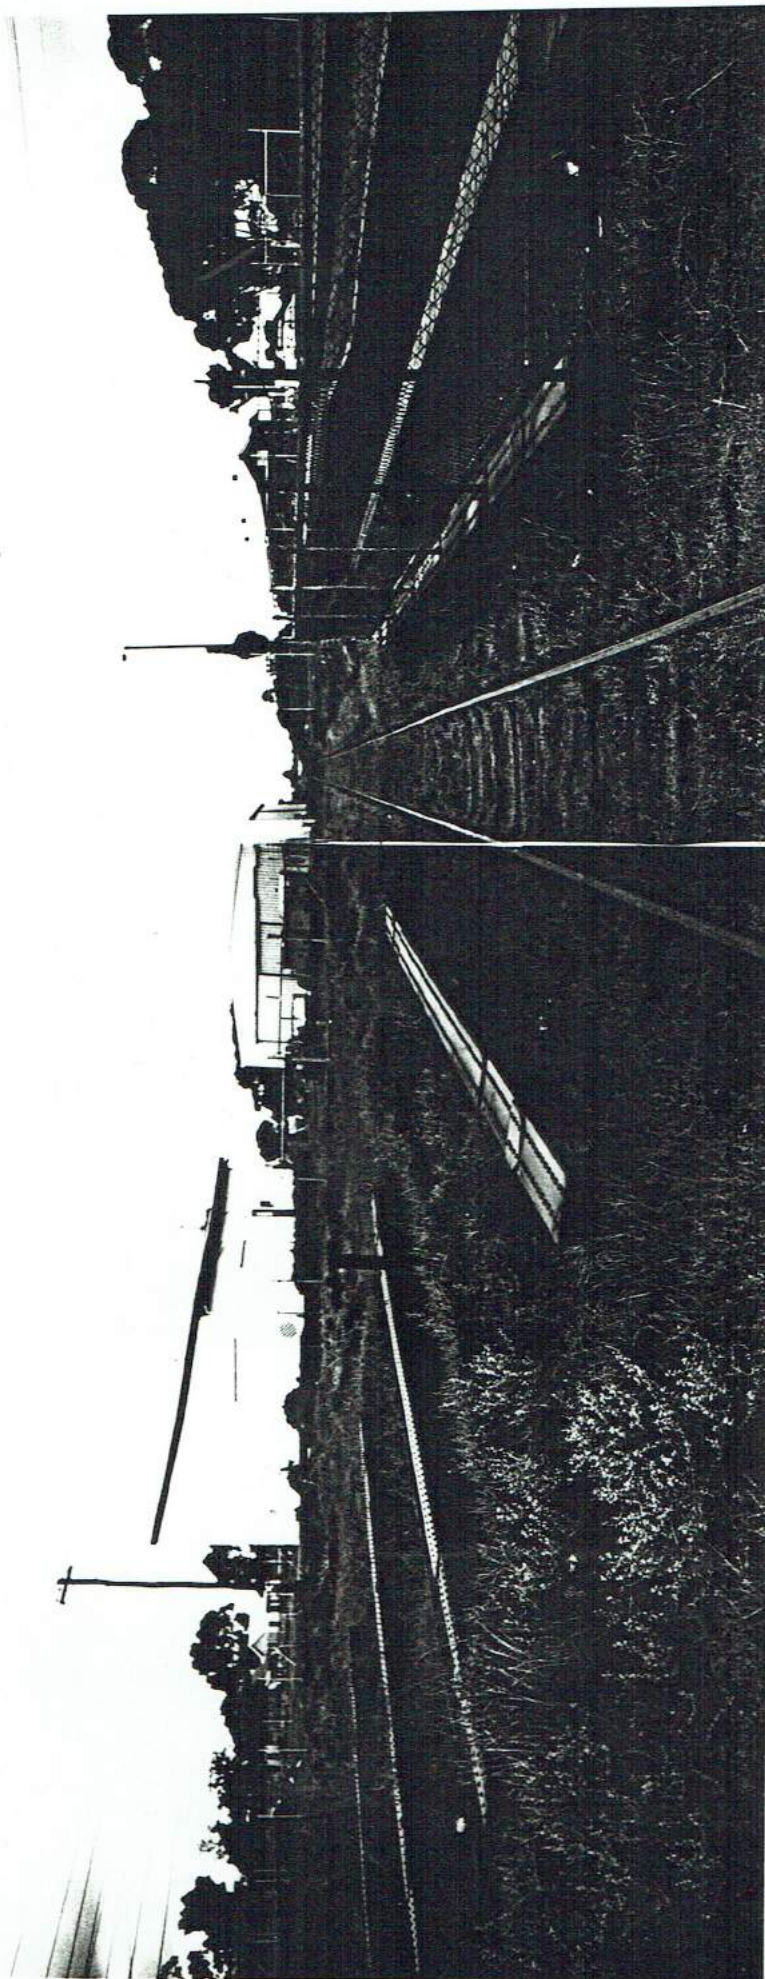
FIGURE 8

The main longitudinal structural bridge support beams (Figures 8, 9 and 10) are fabricated riveted plate girders supporting fabricated riveted steel troughs which support the ballast and rail tracks.

SUBWAY BRIDGE STRUCTURE.

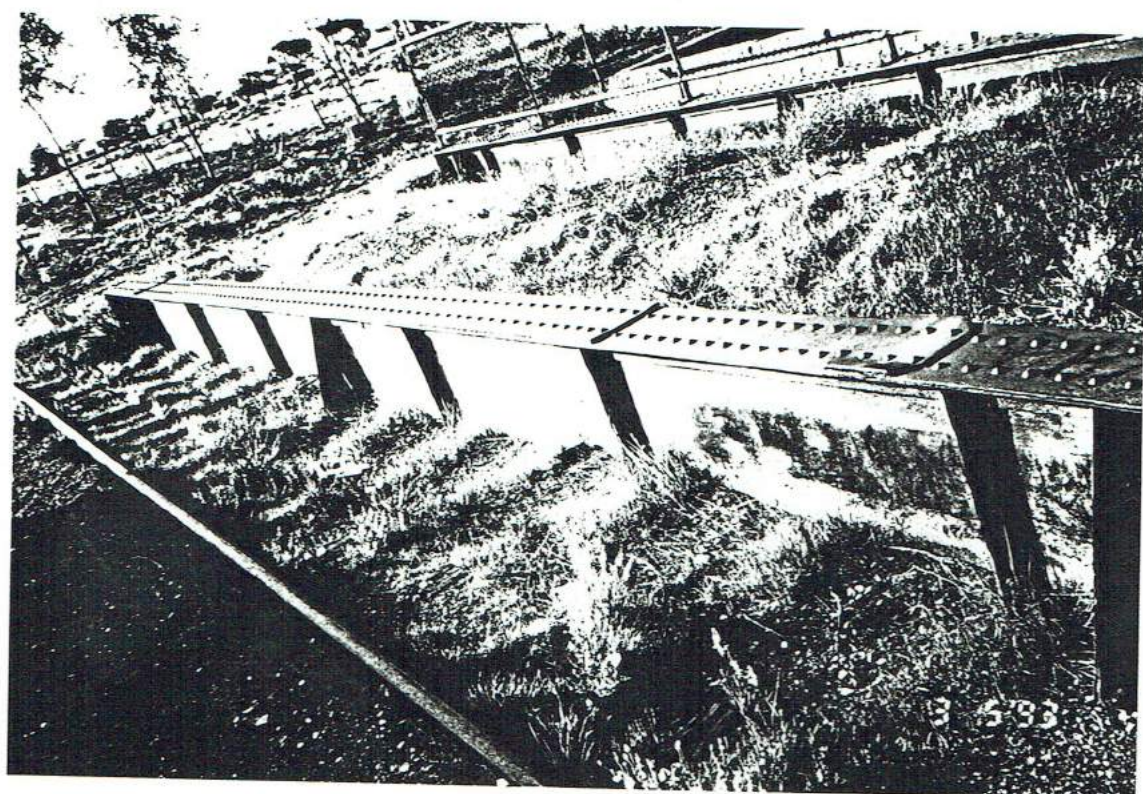
PHOTO OF PLATE GIRDER BRIDGE BEAM. FIGURE 9.

There is a small amount of corrosion on the main longitudinal beams which considering their age could be a reflection on the fairly dry conditions in Kalgoorlie as well as bitumen corrosion protection being originally applied. The corrosion of the longitudinal beams is not considered to be significant enough to be a structural problem for the present usage, however further investigation is considered necessary.

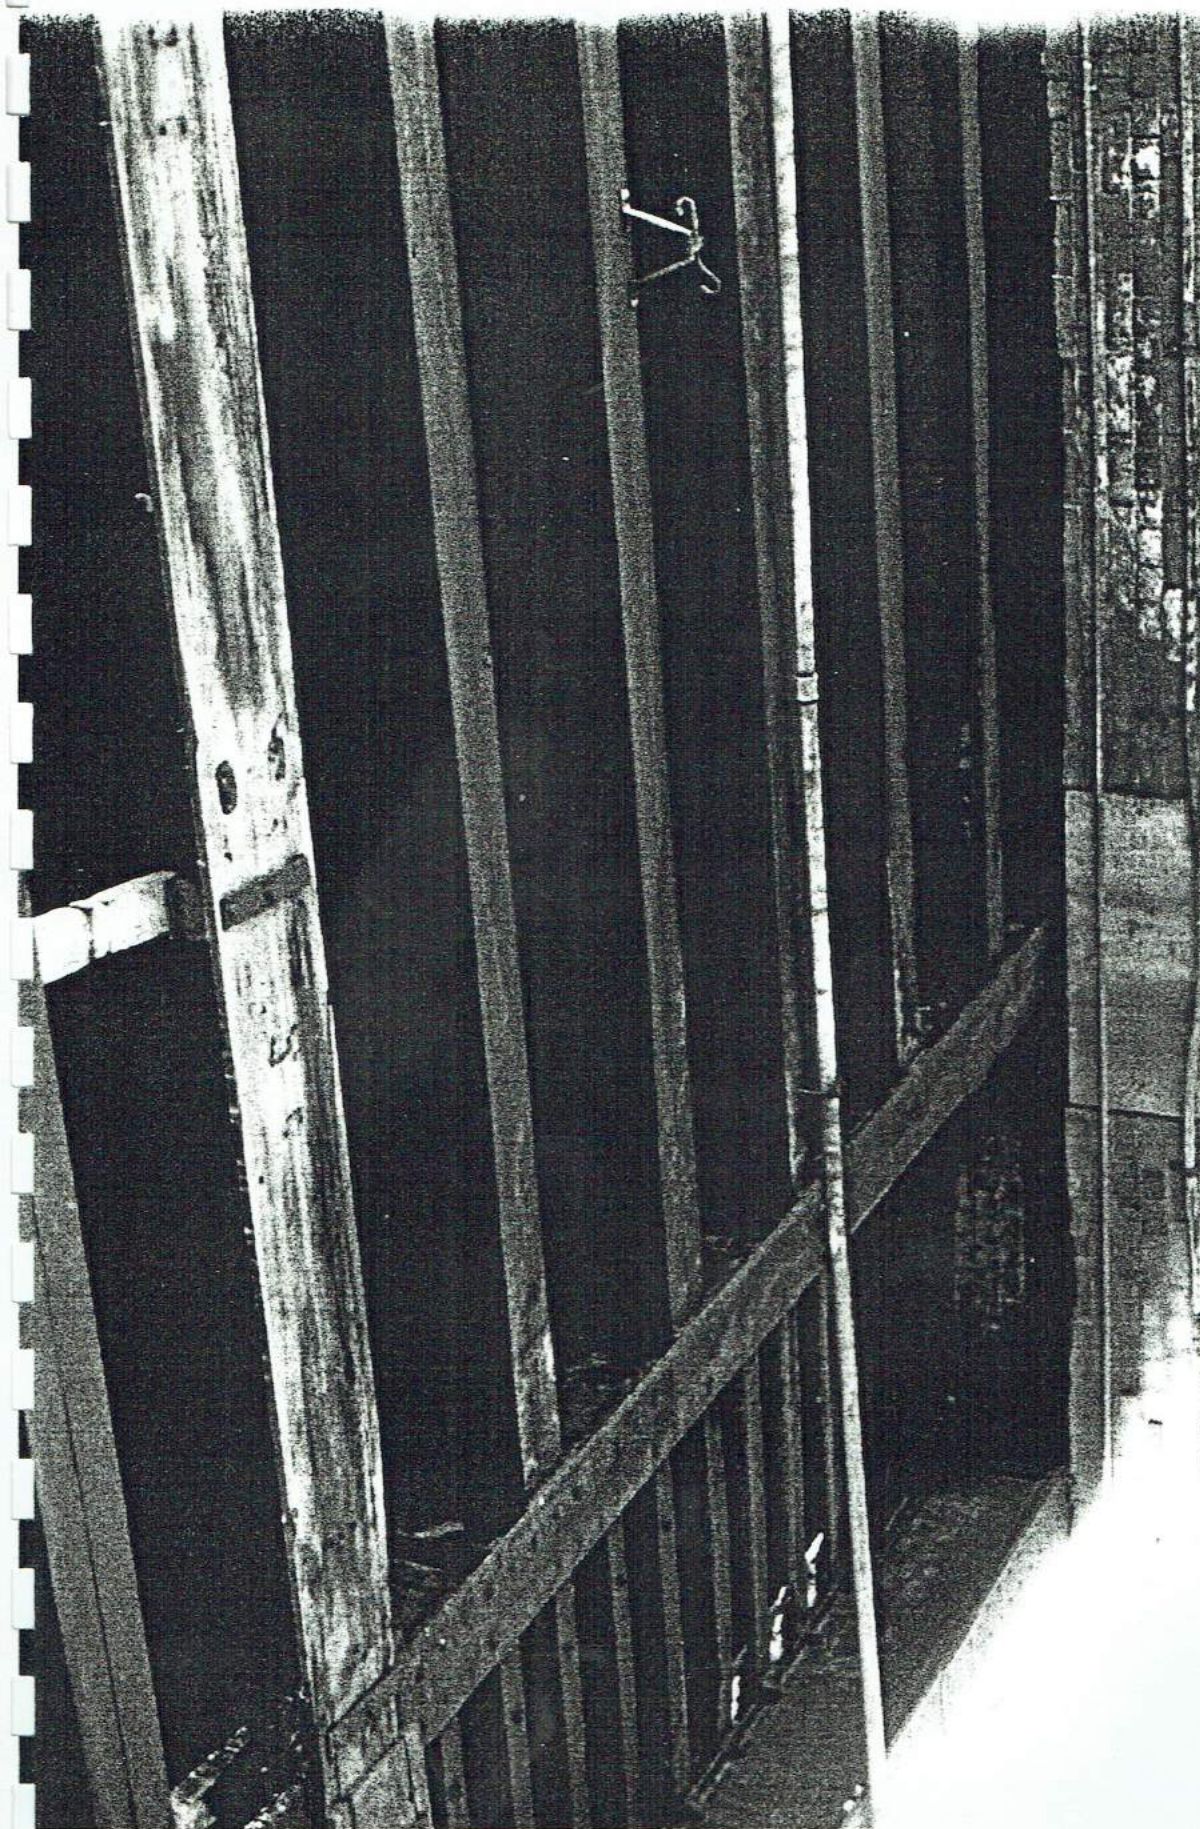
FIGURE 10.

The lighter transverse steel troughing (13.4lbs per foot) supporting the 14.3 metre wide roadway on the eastern section of the subway does not appear to have been coated with bitumen on the upper surface resulting in extensive corrosion. This corrosion together with the thinner steel plate used for this troughing has resulted in this section of the deck being unserviceable.

This deteriorated decking originally supported a roadway since removed. The rail tracks are being supported on the section of heavier decking and bridge girders which were also protected by a bitumen coating.

UNDERSIDE OF SUBWAY BRIDGE DECK

1. The immediate work required on the basis of safety is the removal of the 14.3 metre eastern section of 13.4 pounds per foot decking previously supporting a section of roadway and the fencing of this area.
2. The visual structural assessment needs to be backed up by further investigations such as measurement of steel thicknesses in the semi-circular troughs and the main girder web and check structural calculations carried out.
3. Removal or repair of the outer beams damaged by overheight vehicles.
4. Repair of fretting brickwork.
5. Replacement of hand rails.
6. Consideration of replacement of the removed section of 13.4 pound per foot decking supporting the original roadwork. listed in 1 above.
7. The early Westrail files have not as yet been located to signify the engineers involved with the original subway design and construction the original plans (Appendix 2) being unsigned.

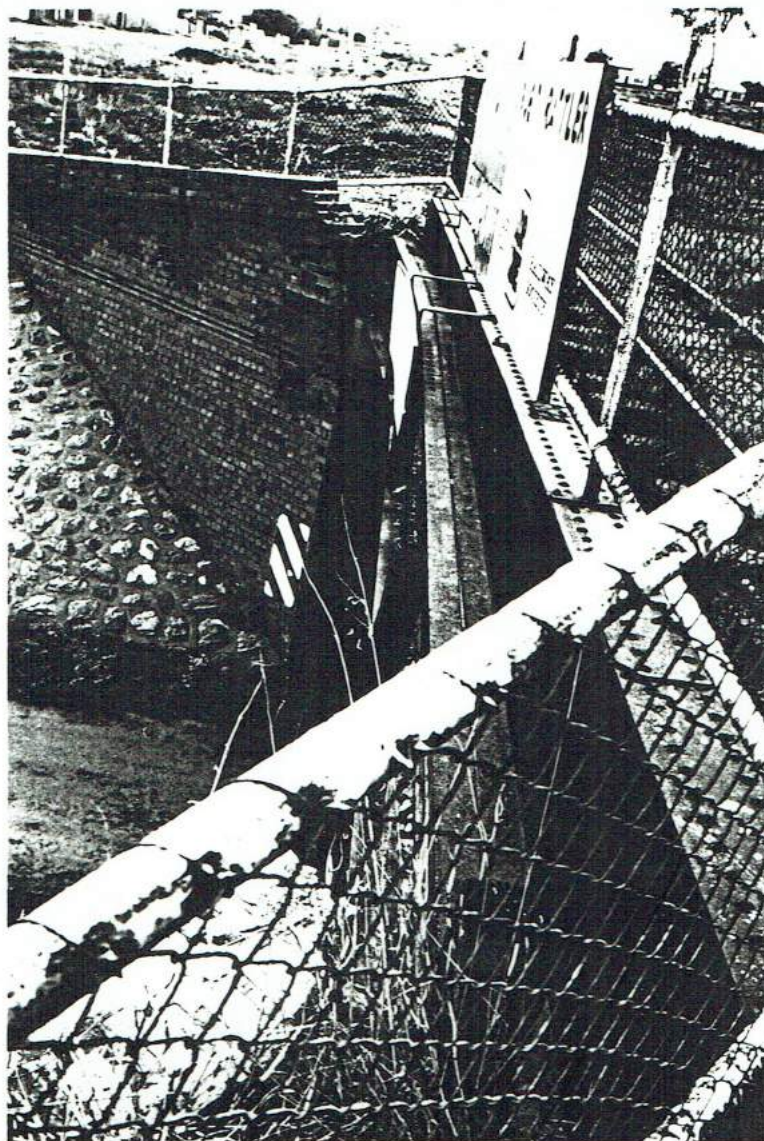
PHOTO OF DAMAGED PARAPET EDGE BEAMS. FIGURE 11.

The two extreme outside edge beams do not perform a rail bridge support function. Their purpose being to support "architectural" parapet face brickwork and also to withstand the impact of overheight vehicles attempting to pass under the subway, both beams (Figure 11) have performed this function having been hit by overheight vehicles. The beams are bent and the brickwork has been removed.

As previously outlined the parapet walls at each end of the subway have been removed due to damage of the supporting beams.

The subway is currently serviceable and represents the original construction. The restoration required includes the face brickwork in sections of the wing and parapet walls, the replacement of the corroded bridge decking in the 14.3 metre eastern section, which originally supported a roadway, and the beams at each end of the subway protecting the subway bridge from damage by overheight vehicles.
